Manhole Inspection Summary

Manhole # S39K__028MH

Insp Date: **7/30/08 2:00 PM**

Location Address: **801 eastern av**

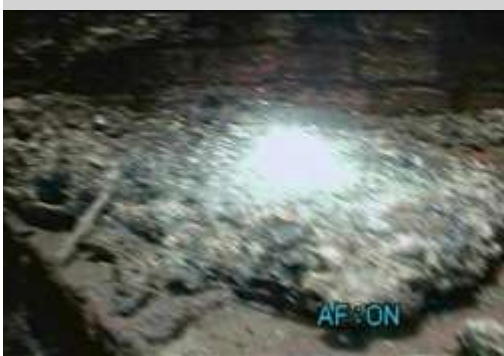
Defect 3

Condition: ☐ Sound ☐ Cracked ☐ Root Intrusion ☐ Deteriorated ☐ Leaks ☒ **Debris**

bench debris

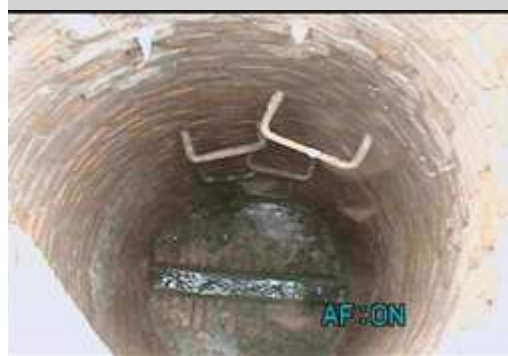
Defect 2

Steps Count: **7** Missing: **1** ☒ **Corroded**

steps

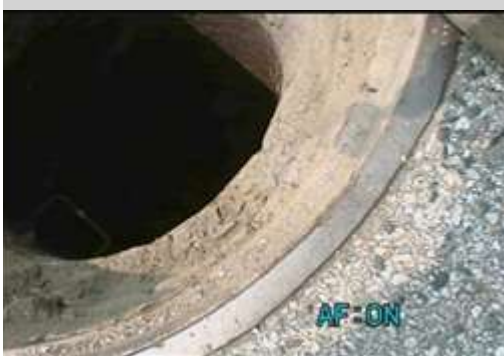
Defect 1

Frame Offset: **3** (in.) Condition: ☒ Sound ☐ Cracked ☐ Leaks

offset

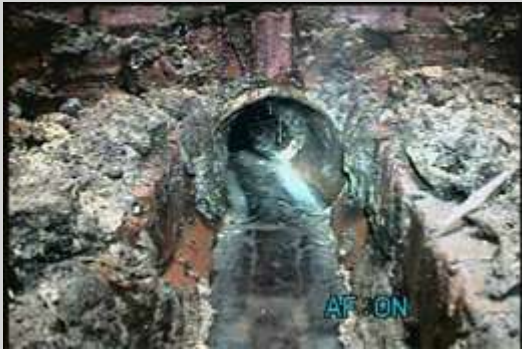
12 O'Clock Outflow

8 in. Circular Gravity Sewer
Pipe Out @ 12 O'Clock

Invert Depth: **12.58** (ft.) Flow Characteristics: **Fast**

Deposits: ☒ None ☐ Mud ☐ Sludge ☐ Debris ☐ Grease

Infiltration: **None**

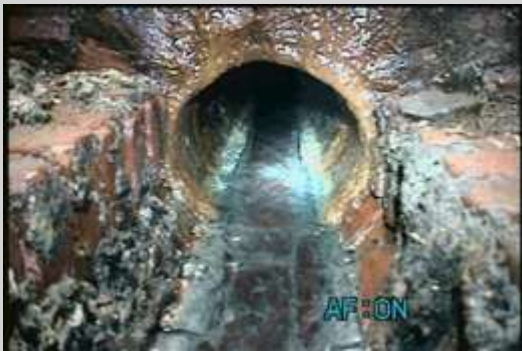
6 O'Clock Inflow

8 in. Circular Gravity Sewer
Pipe In @ 6 O'Clock

Invert Depth: **12.54** (ft.) Flow Characteristics: **Fast**

Deposits: ☒ None ☐ Mud ☐ Sludge ☐ Debris ☐ Grease

Infiltration: **None**
